Manhole Inspection Summary

Manhole # S41A1_009MH

Insp Date: **12/18/08 10:29 AM**

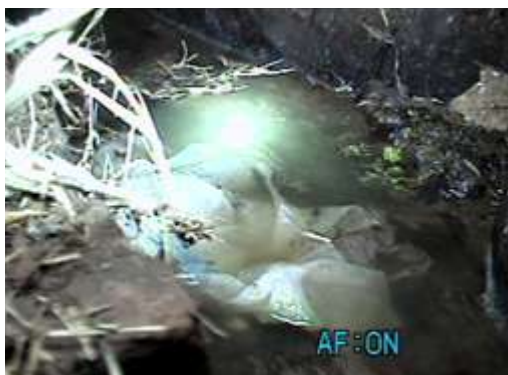
Misc channel debris

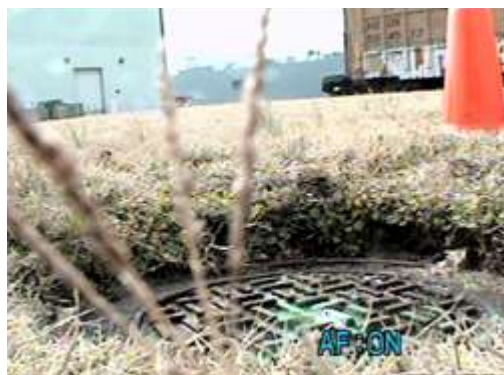
Defect 4

channel debris

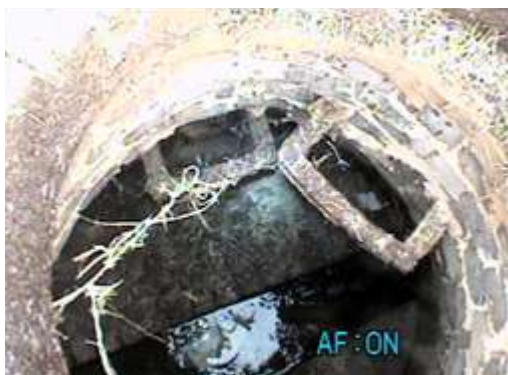
Defect 2

Diameter: **26** (in.) Length: **0** (in.) Dist A/B Grade: **-3** (in.)

below grade

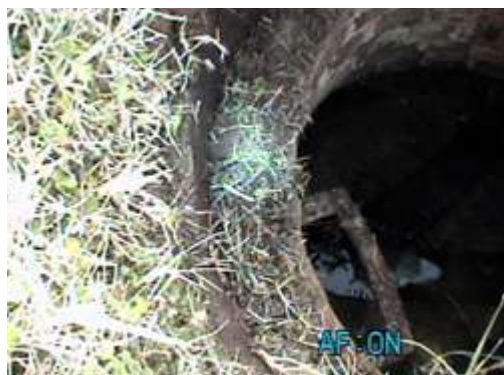
Defect 1

Count: **2** Missing: **0** ☒ Corroded

cor. steps

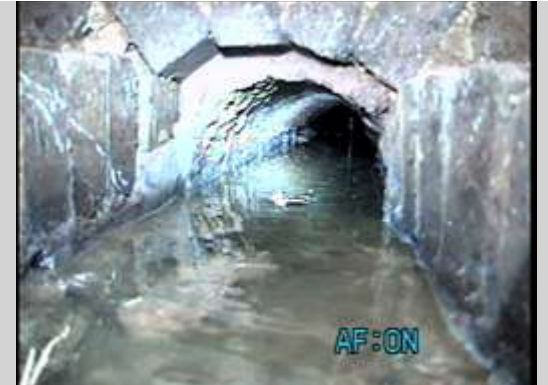
12 O'Clock Outflow

8 in. Circular Gravity Sewer
Pipe Out @ 12 O'Clock

Invert Depth: 5.10 (ft.) Flow Characteristics: **Slow**

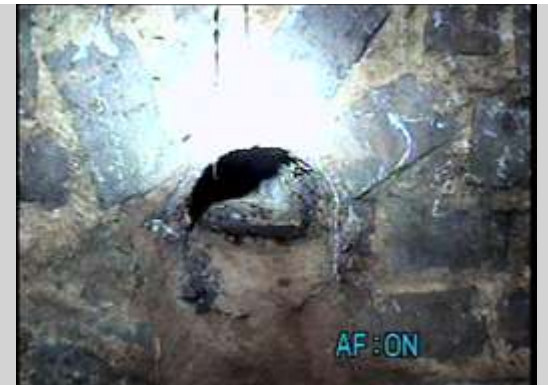
4 O'Clock Inflow

6 in. Circular Gravity Sewer
Pipe In @ 4 O'Clock

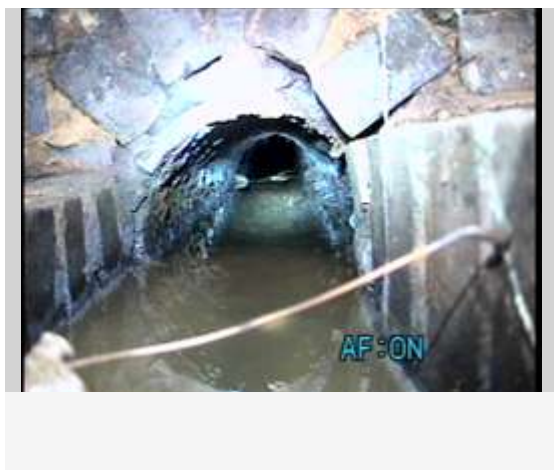
6 O'Clock Inflow

6 in. Circular Gravity Sewer
Pipe In @ 6 O'Clock
